# FOSTER CITY COMMUNITY RECREATION CENTER FEASIBILITY STUDY

JULY 1993

CITY OF FOSTER CITY  
610 FOSTER CITY BLVD.  
FOSTER CITY CA. 94404

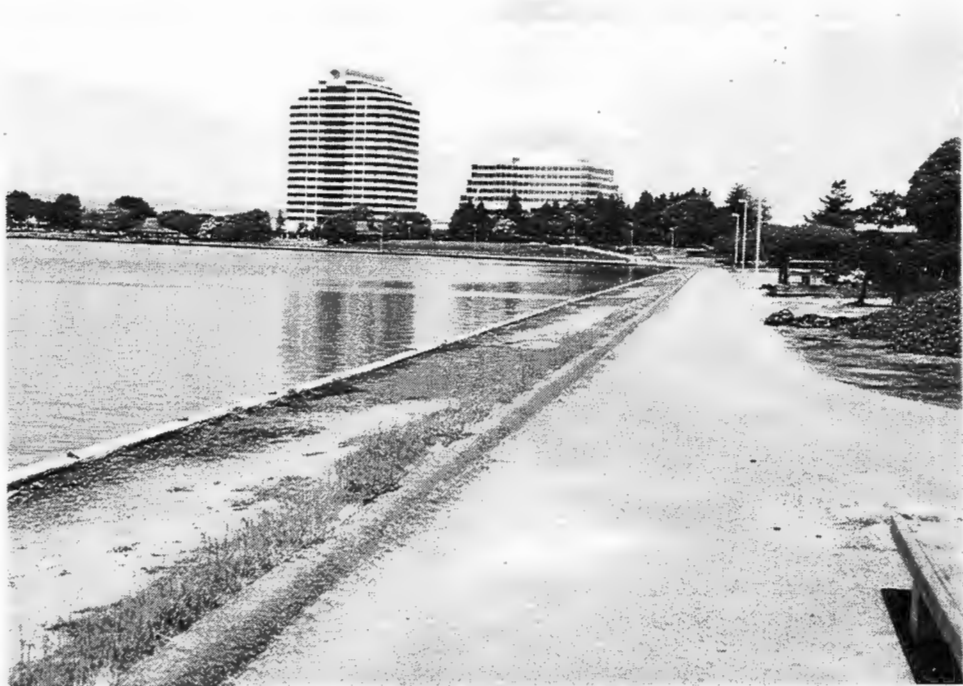
Waterfront Promenade between Boat Launch and Recreation Center

13. The Waterfront Promenade along the Central Lagoon from the Boat Launch to the Recreation Center should be improved. Its current condition is not in keeping with the rest of Ryan Park's landscaping materials along the Central Lagoon.

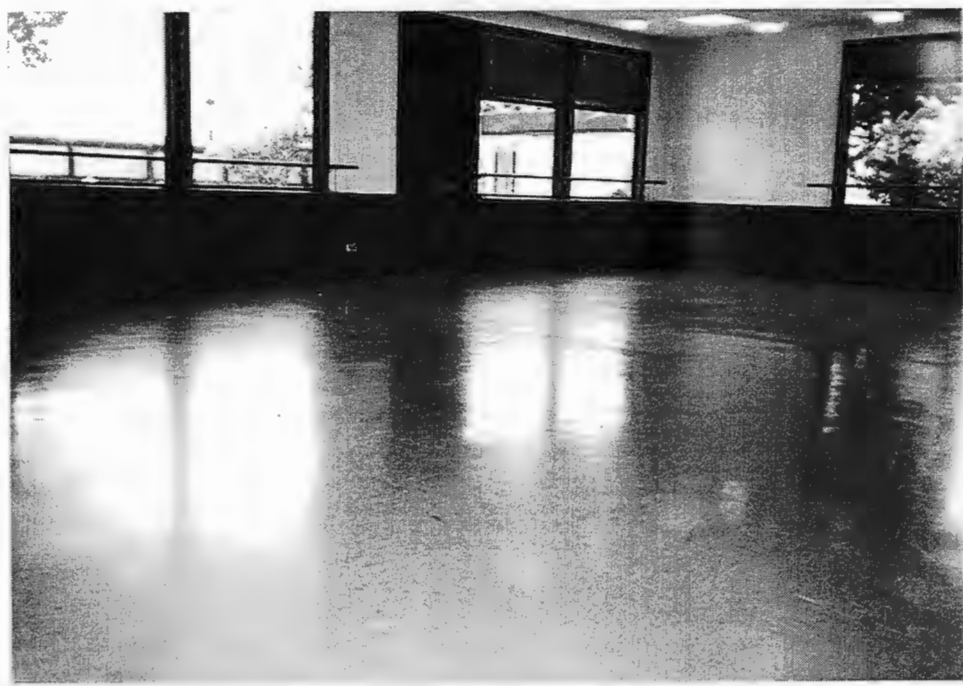
Room 105 - Dance Studio/Teen Center

Room 105- Dance Studio/Teen Center- replacement of vinyl flooring tiles with a cushioned resilient flooring material.

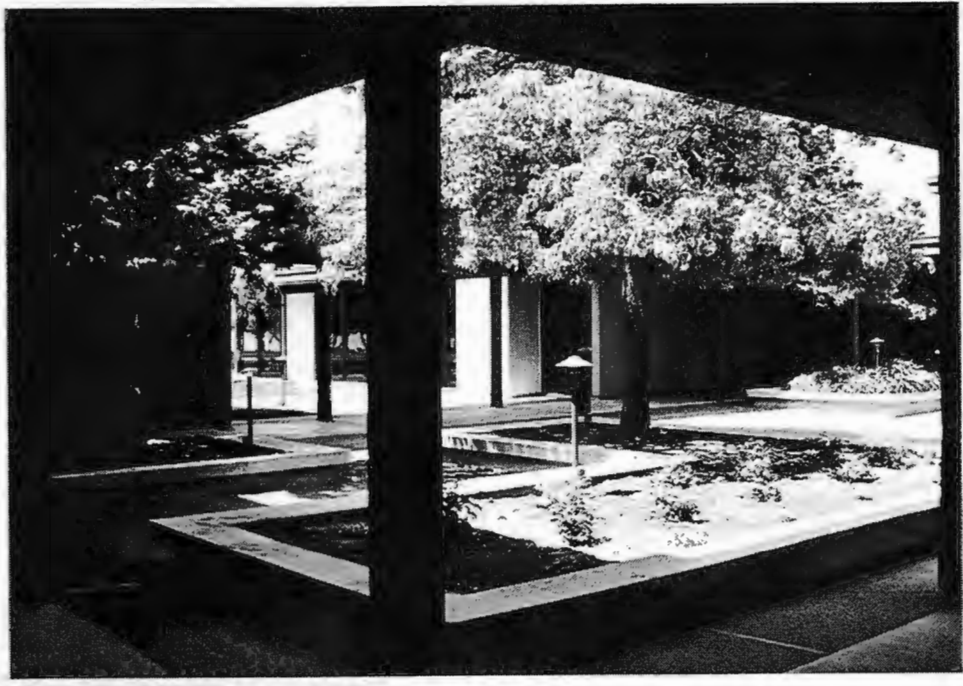
Underutilized Central Courtyard

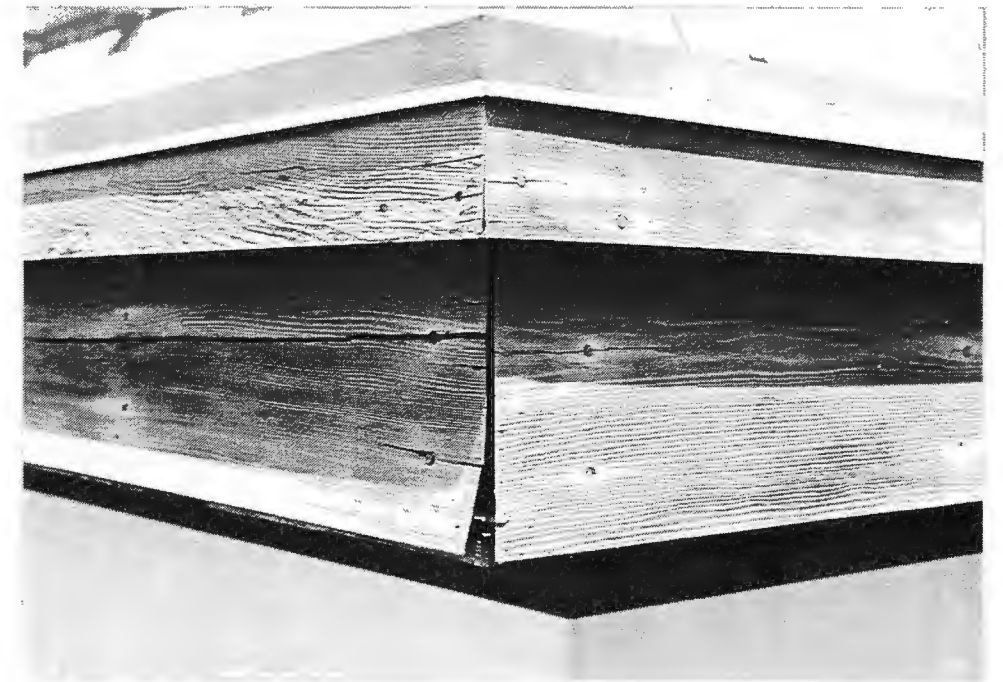
Warped Fascia Boards at Roof Eaves

Replace warped fascia boards with new 2 x 12 kerfed boards at all roof eaves. Constant exposure to sunlight and moisture has proved menacing.

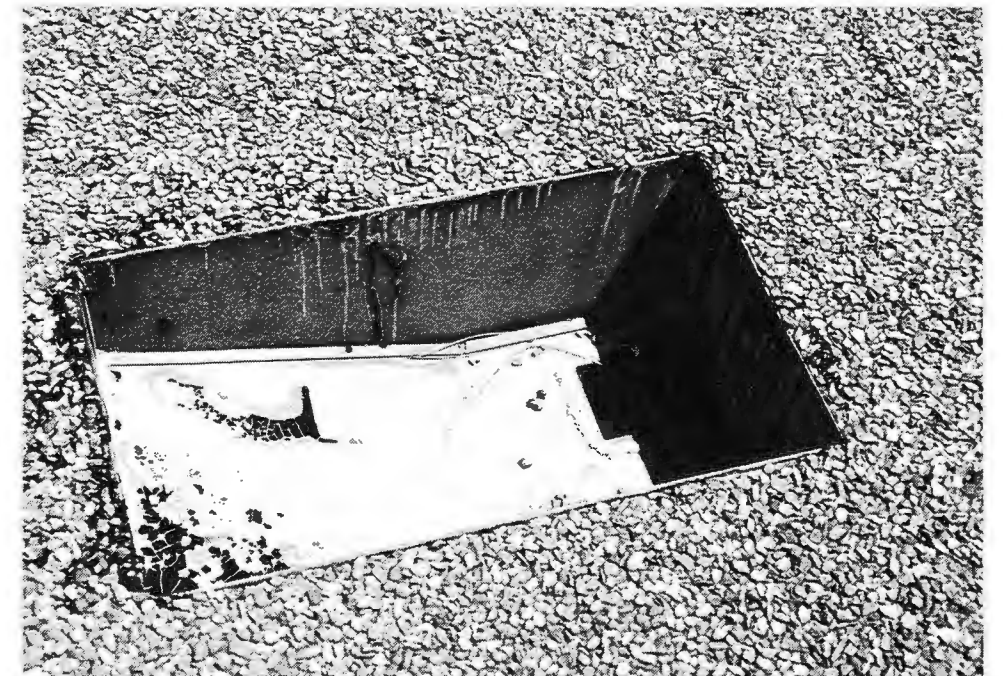
Sump type Roof Drain missing strainer, many are full of Leaves and Debris

Replacing the existing roof with a code conforming 1/4" per ft. sloped roof substrate and 4 ply built-up roof membrane with traffic topping surface. New drains with 2" overflows are recommended with reinstallation of galvanized metal flashings at roof edges. Additional ceiling insulation should also be added in conjunction with the replacement of the roof.

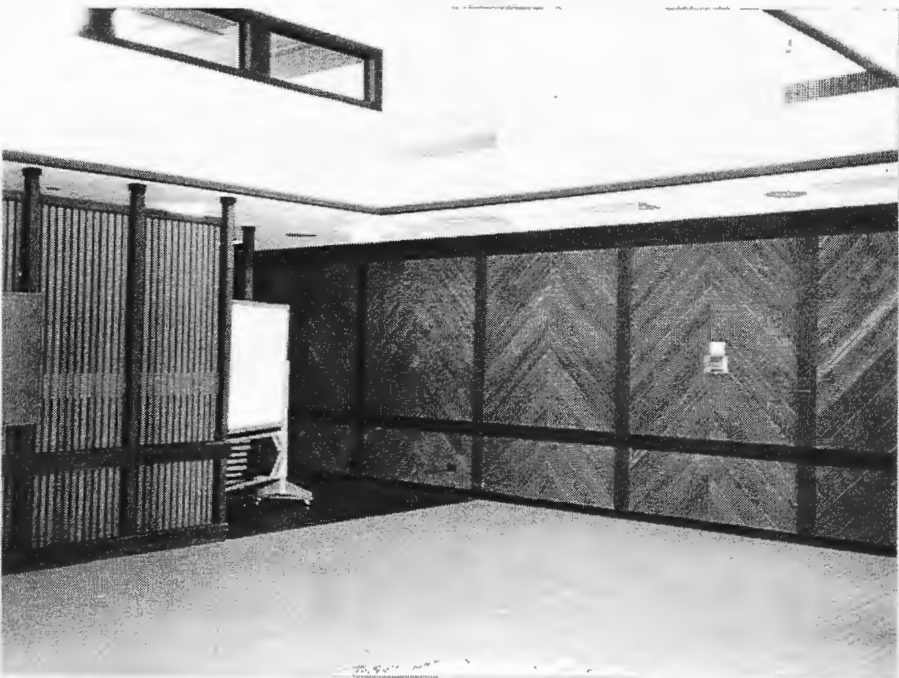
Dark interior wood siding within Conference Room

4. The Conference Room needs to have a more light open appearance. It is recommended to replace wallcoverings, window shades and carpet with lighter color light reflective finishes.

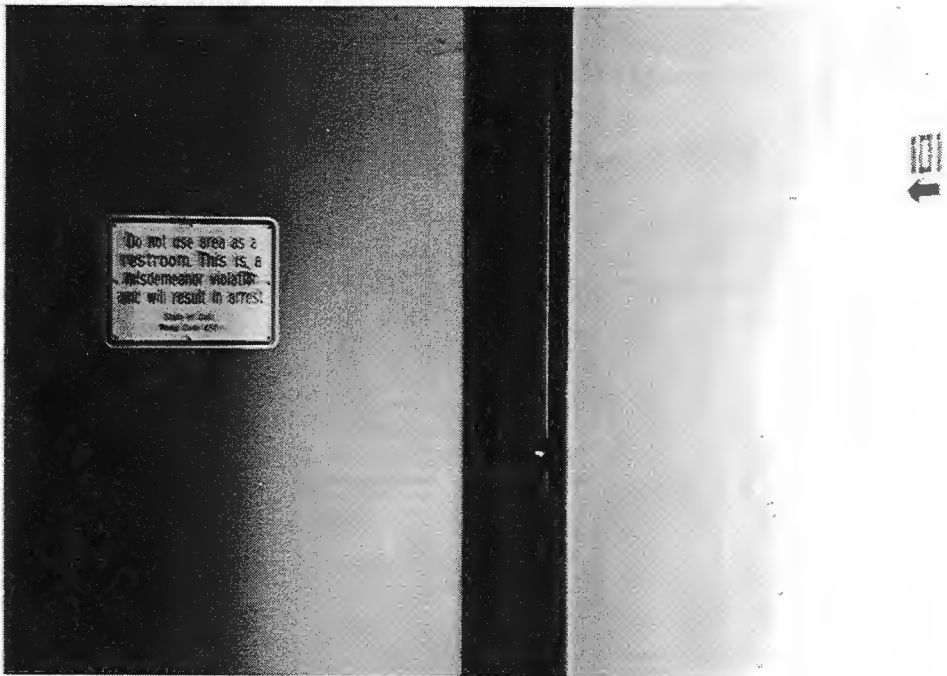
Deep vestibule at Ceramics Studio

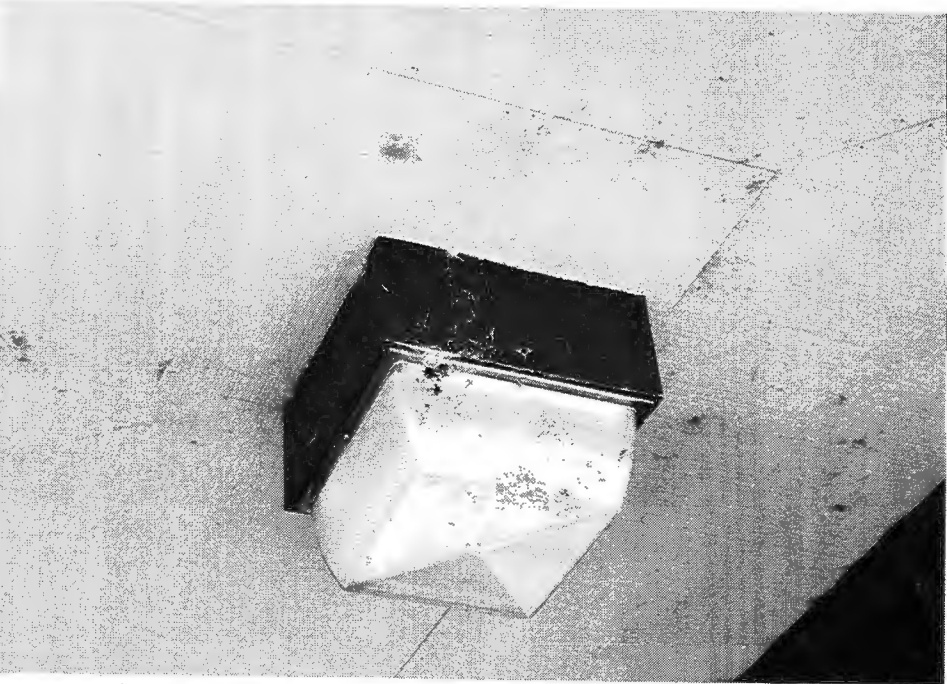
Surface mounted vandal-proof fluorescent type light fixtures are affixed to the underside of the covered walkway plywood soffits, casting a low, dreary light quality upon the walkway surfaces. Attributable to the lightsource type, the quality of light would improve by changing or increasing the lighting intensity by adding more fixtures at or changing fixture types at sparsely placed bollard type lights which highlight plant groupings within the courtyards and plazas while illuminating walkway surfaces not under cover.

Vandal proof Light Fixture at Covered Walkways

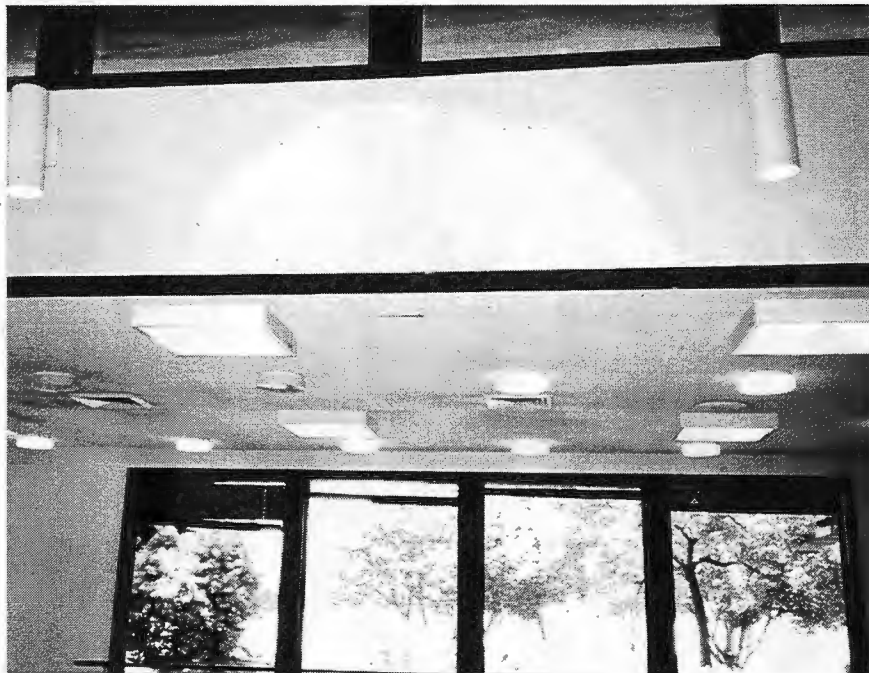
Typical lighting layout within Recreation Center

Replacement of existing fluorescent light fixtures within areas where existing lighting conditions are inadequate. For instance, the Main Hall lighting configuration doesn't allow for the proper diffusion of light due to the ceiling height.

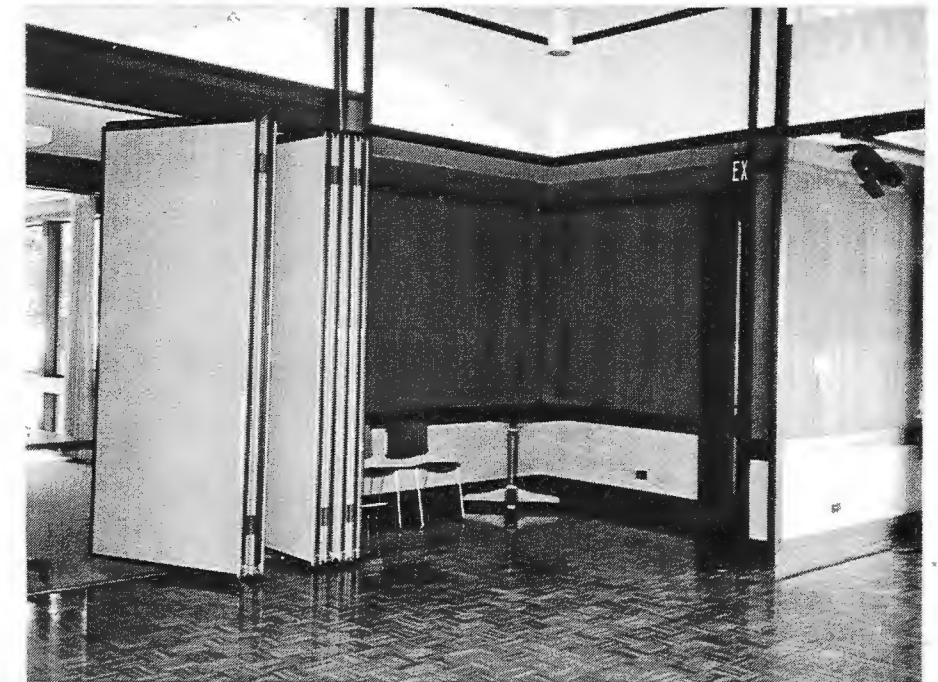
Sliding Acoustical Panels require replacement to allow multiple users within the Main Hall

Improve acoustical conditions at the Main Hall by removing existing sliding partitions and replacing them with a more effective commercial type system that has a minimum STC rating of 50.

As a major consideration in the design of a multi-purpose room with partitions such as the Recreation Center's Main Hall acoustical system, an STC rating within the 50-55 range should be maintained to accommodate all possible user group arrangements. By stopping the noise emissions to adjoining areas such as the Conference Room/Kitchen or Administration offices and Art Gallery, the room can function properly, allowing for optimal use by all. Though it is difficult to determine the existing STC ratings of the Main Hall construction assemblies without performing acoustical tests, it is apparent an acoustical treatment decreasing the noise levels throughout the Recreation Center is advisable.

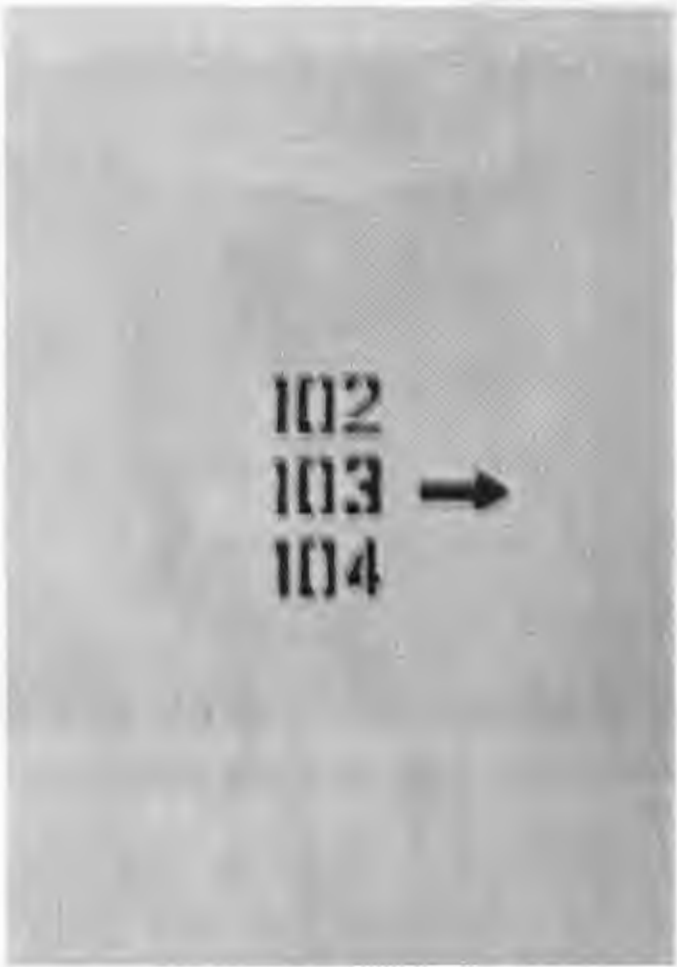
Current Directory Signage at the Recreation Center

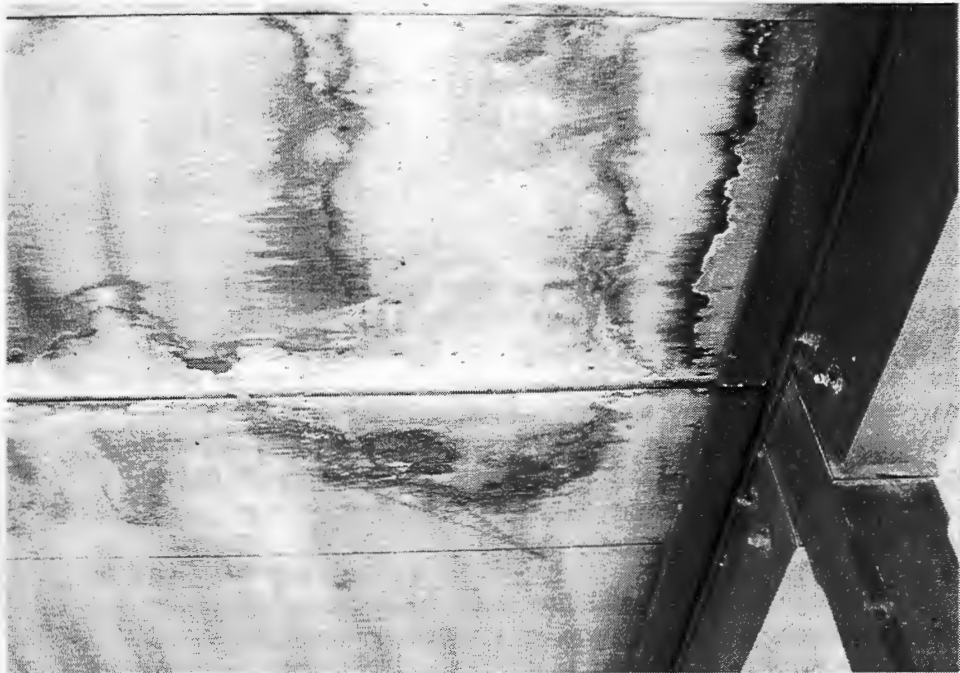
Water damage at Walkway Soffits

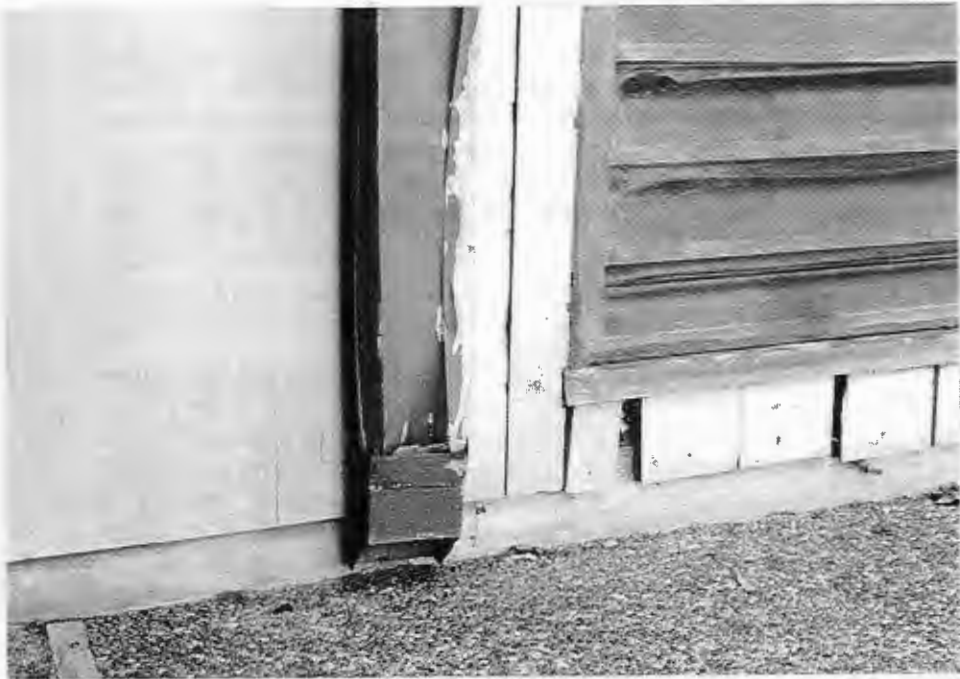
Damaged Downspout and Exterior Siding

Replacement of existing exterior 1 x 6 redwood siding with an exterior cement plaster finish incorporating an integral color system and vandal-proof sealers.

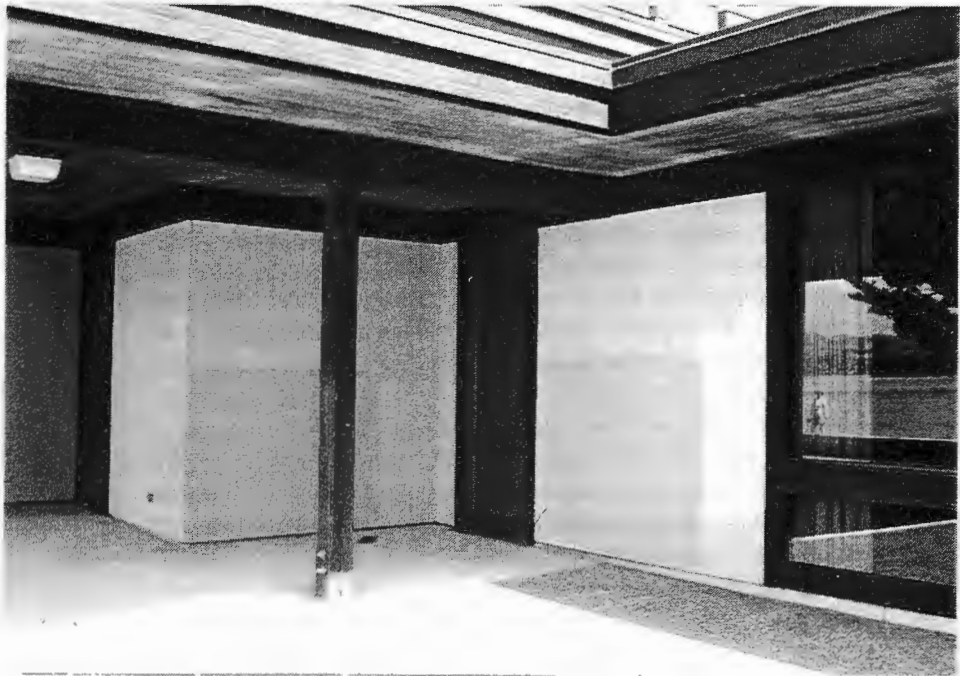
Splotchy paint patches resulting from graffiti

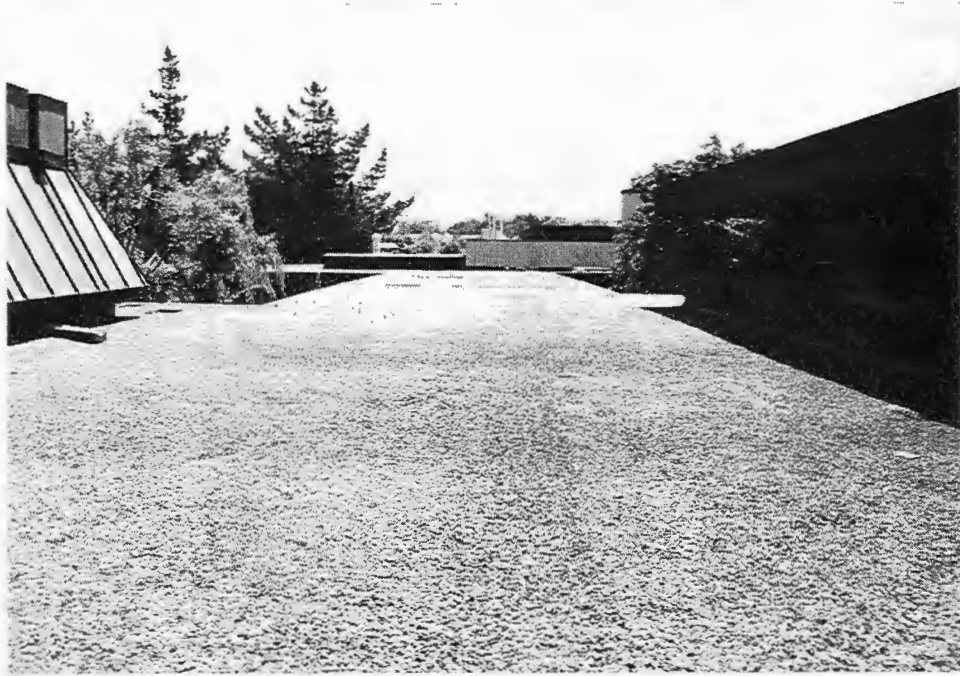
Flat roof without any slope
